# B.M.C. SERVICE BULLETIN

No. GN / 194

## DOOR LOCKS

AUSTIN 1100

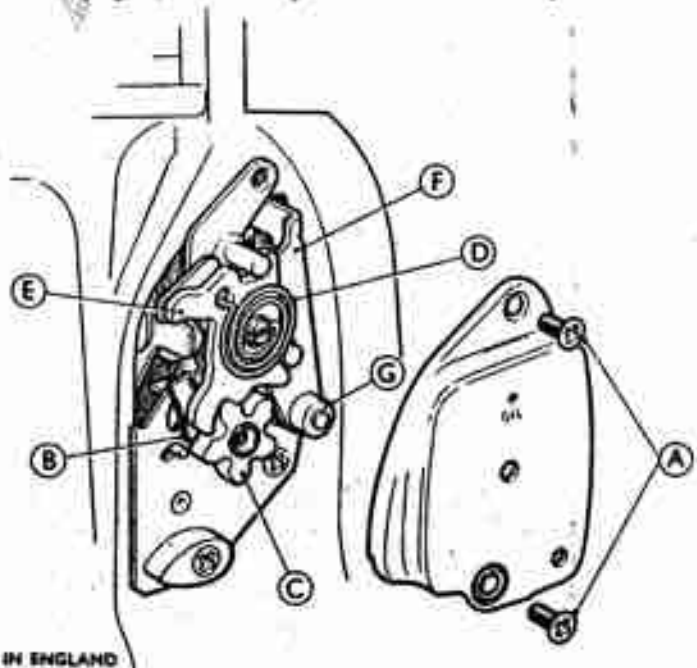
Where the front doors cannot readily be locked or unlocked with the key, the cause is usually the lower lobe of the locking lever 'B' jamming against the back of the rotor teeth sufficiently to prevent key operation. This is consequent upon these parts being subjected to side pressure when the door is in the closed position.

First remove screws 'A' so that lock cover can be taken off to expose internal mechanism. The lower lobe of locking lever 'B', i.e., the lever actually operated by the key device, will then be visible but to facilitate matters, lift off rotor 'C', pawl spring 'D' and pawl 'E'. The contactor 'F' and loose bush 'G' need not be disturbed.

The end of lobe 'B' must be bent downwards towards the backplate,  $\frac{3}{64}$ " 1.19 mm, along  $\frac{1}{4}$ " 6.35 of its length, so that it cannot come into contact with the back of the rotor teeth under any circumstances. At the same time the action of the over-centre spring immediately behind the lobe must not be obstructed.

Before replacing the components, ensure that there are no abrasions on the locking lever 'B', particularly on the raised portion above the lobe.

**NOTE:** The rotor must be replaced so that the flat side of its tooth form coincides with the flat portion on the pawl 'E'.
